Birdsall Inspections, LLC
Home Inspections for New Hampshire

Confidential Inspection Report

LOCATED AT:
29 Spring St
Laconia, New Hampshire 03246

INSPECTED ON:
Jan 7, 2018

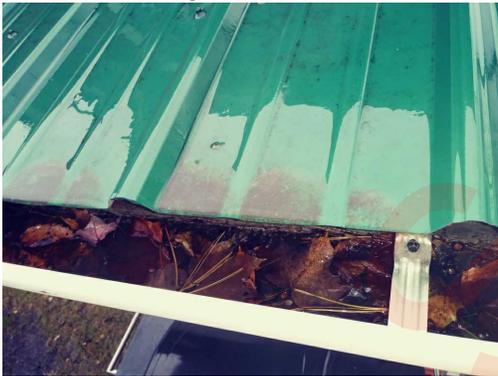
33: - The gutters are filled with debris. We recommend all debris be removed to ensure proper drainage. The condition of the gutters can be better assessed at that time.

34: - The gutters do not have enough downspouts or they are not strategically located. We recommend that additional downspouts be installed.
